PHOTOGRAPHIC INTELLIGENCE REPORT

MILITARY FACILITIES
PU-ERH (NING-ERH), CHINA

CIA/PIR 77033

DATE AUGUST 1966
COPY
PAGES 26

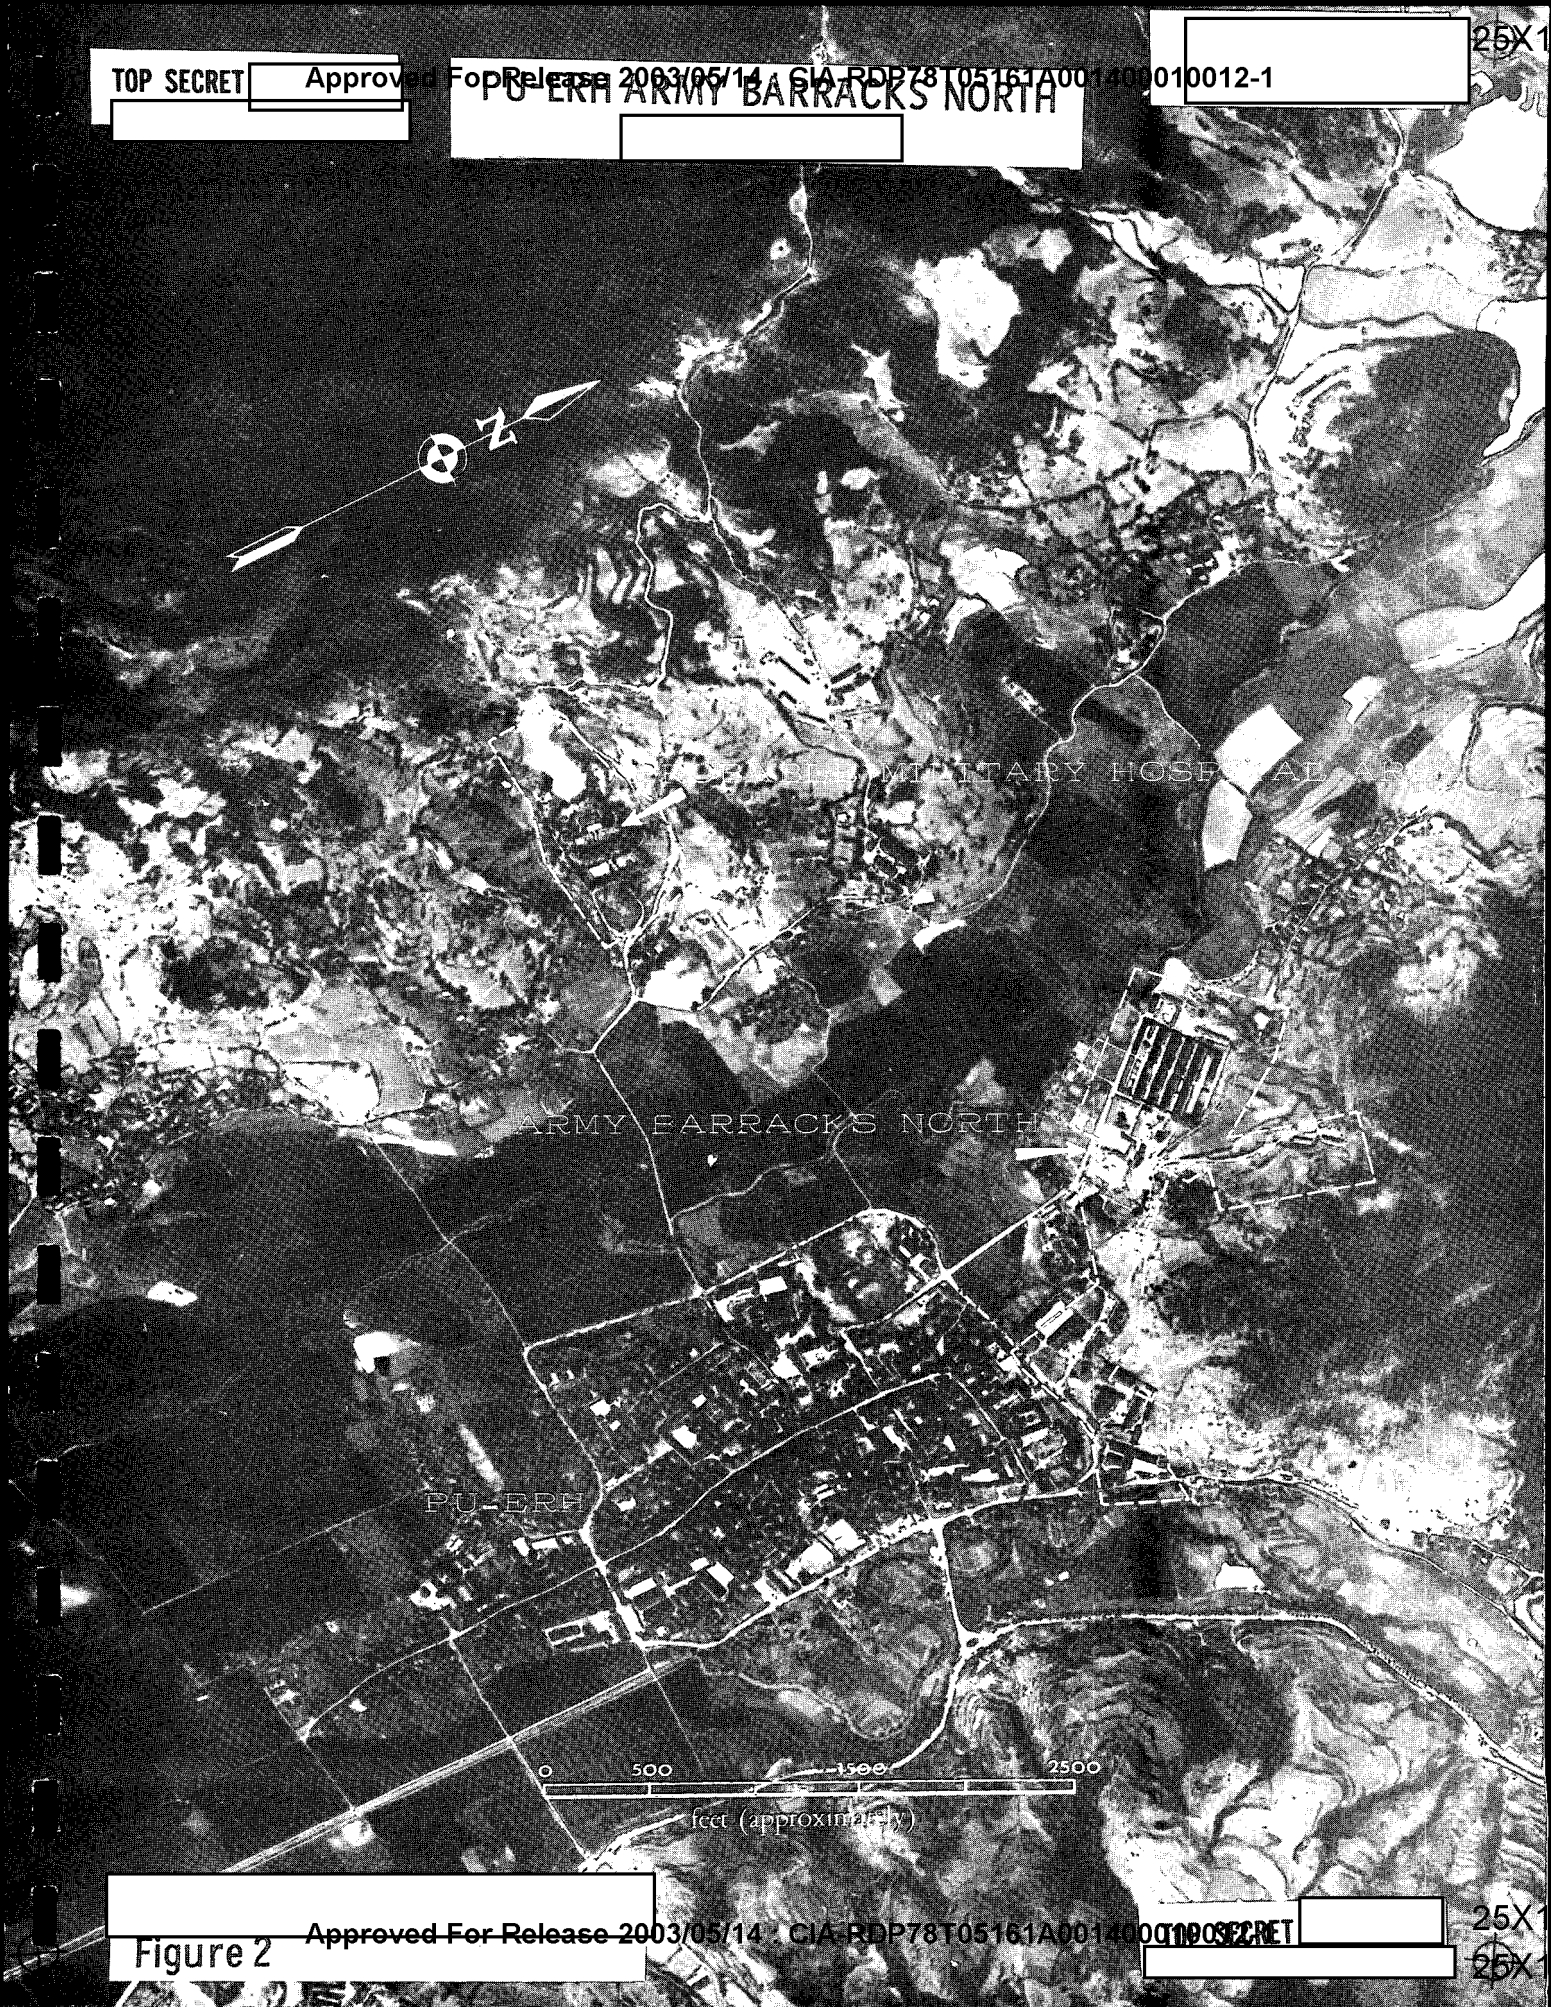
Figure 2

PU-ERH ARMY BARRACKS NORTH is located on the northern edge of PU-ERH. A probable military hospital is located 0.5 nm west (see Figure 2).

PU-ERH ARMY BARRACKS NORTH contains one two-story administration building, one one-story administration building, one two-story auditorium/gymnasium, two officer's quarters, one "U"-shaped officer's quarters, eight barracks, four "L"-shaped barracks, four storage buildings, one monitor-roofed heavy maintenance building, one monitor-roofed maintenance building, one "M" roofed maintenance building, six vehicle/equipment sheds, nine support buildings and an athletic field. The installation is partially walled.

One "U"-shaped officer's quarters
One "U"-shaped equipment storage building
One equipment storage building
(All under construction.)

The officer's quarters are in mid-stage of construction and the equipment storage buildings are complete.

The officer's quarters are completed.

A new road is observed leading eastward from the barracks area to two storage buildings and one support building. This road was not present

A two-story administration building is observed under construction.

The administration building is complete and two storage buildings have been added.

This installation was observed on poor coverage of [] and good coverage of [] The installation is walled and contains one large multistory probable hospital building, one "L"-shaped barracks, one barracks, one storage building and two support buildings. Two "star" patterns are observed in the landscaped garden area. An athletic field is outside the walled area. No changes have been observed.
